Link Operations and Maintenance Facility: East

Connor Lee
Project Engineer

- **Maintenance facility and storage for East Link Expansion**
- **Owner: Sound Transit**
- **Value: \$220 Million**
- **Substantial Completion: September of 2020**
- **Design/Build**
- **30 acre site**

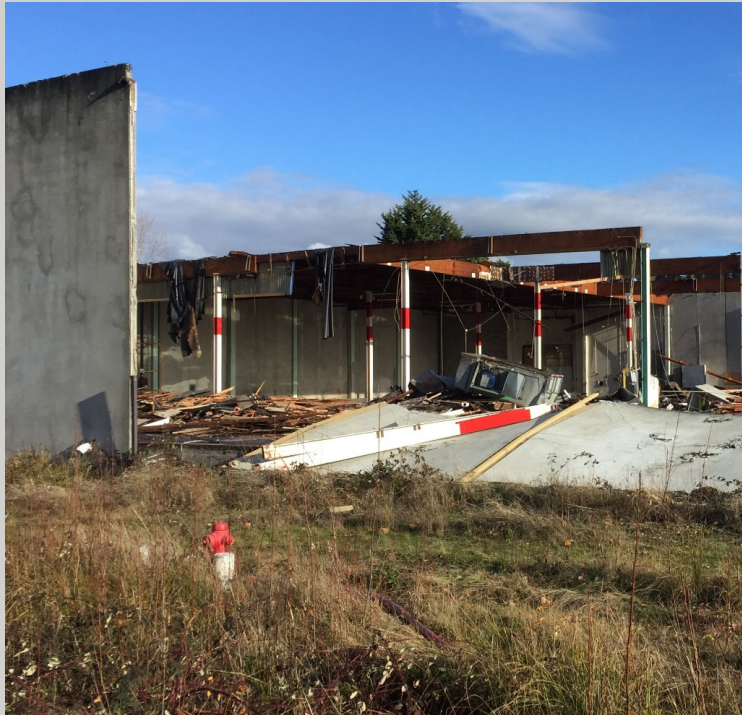
Granite's Role

- **Subcontractor to Hensel Phelps**
- **Original Contract Value: \$28.3 Million**
- **48,000 Man Hours**
- **Scope:**
 - Demo/Clearing
 - Earthwork/Grading
 - Utilities
 - Storm Water Detention Vaults
 - Water
 - Storm
 - Sanitary Sewer
 - KC Sewer Expansion
 - Hardscapes
 - Concrete flatwork
 - Asphalt paving
 - Site retaining walls
 - Erosion Control

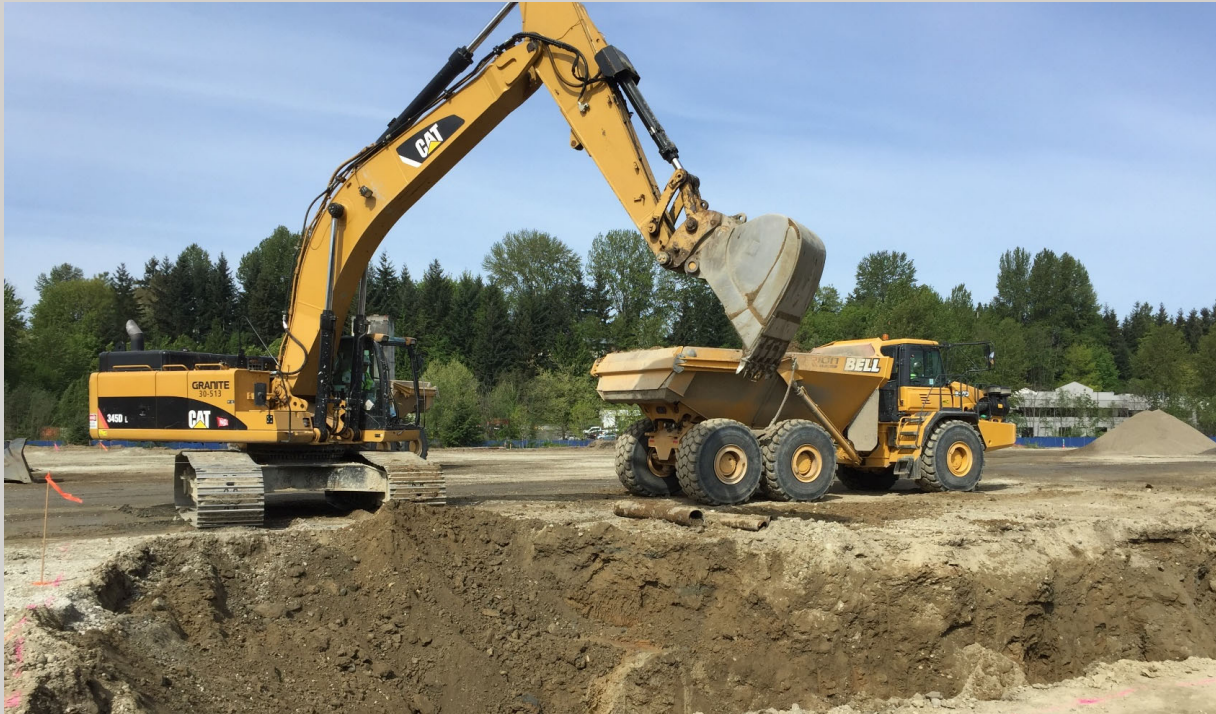
- Subcontracted to Rhine Demolition
- 6 concrete buildings
- 350,000 SF footprint
- 2 month duration

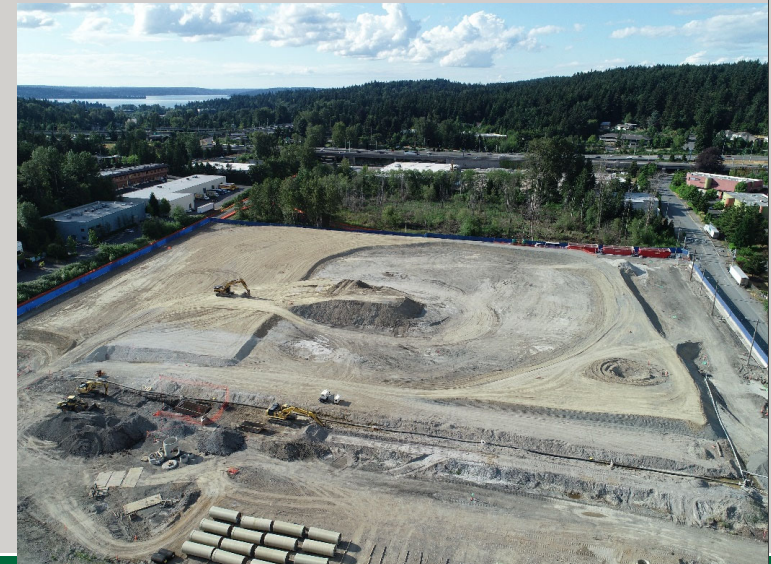
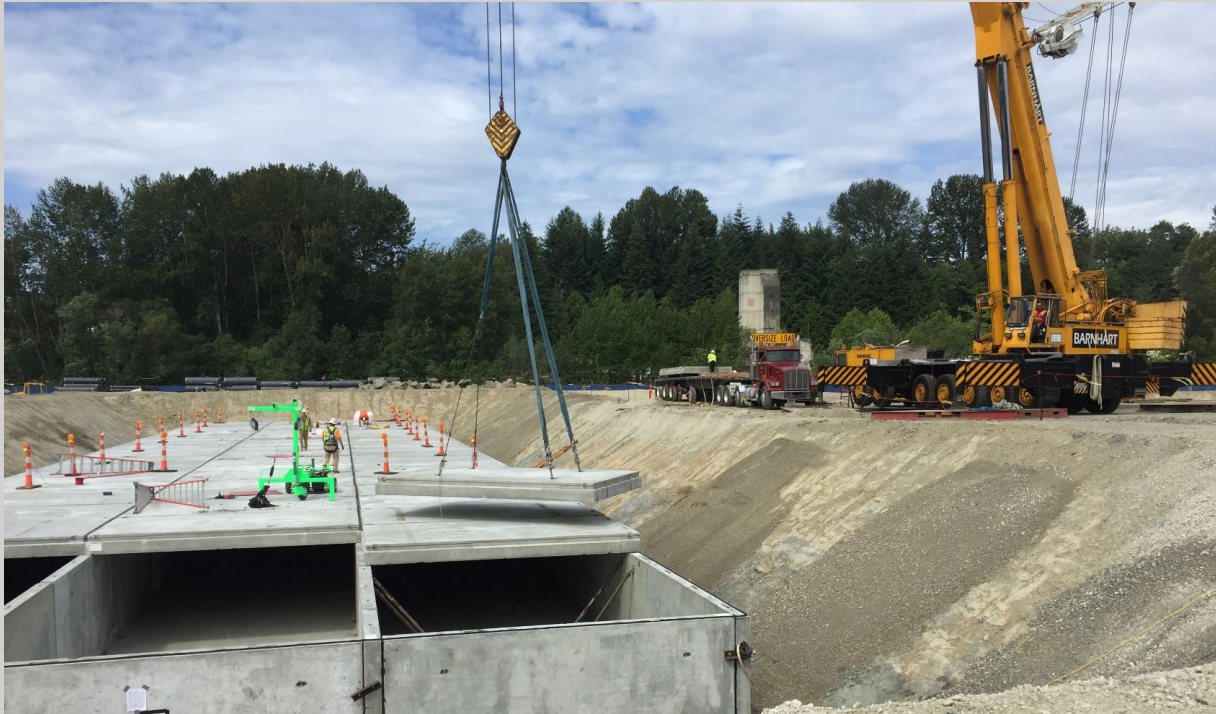
Earthwork / Grading

- 55,000 CY waste off-hauled
- 22,000 CY surcharge material
- 10,000 CY of cement treatment
- 4,900 CY Unsuitable material
- 94,000 SY finish grading
- GPS machine control

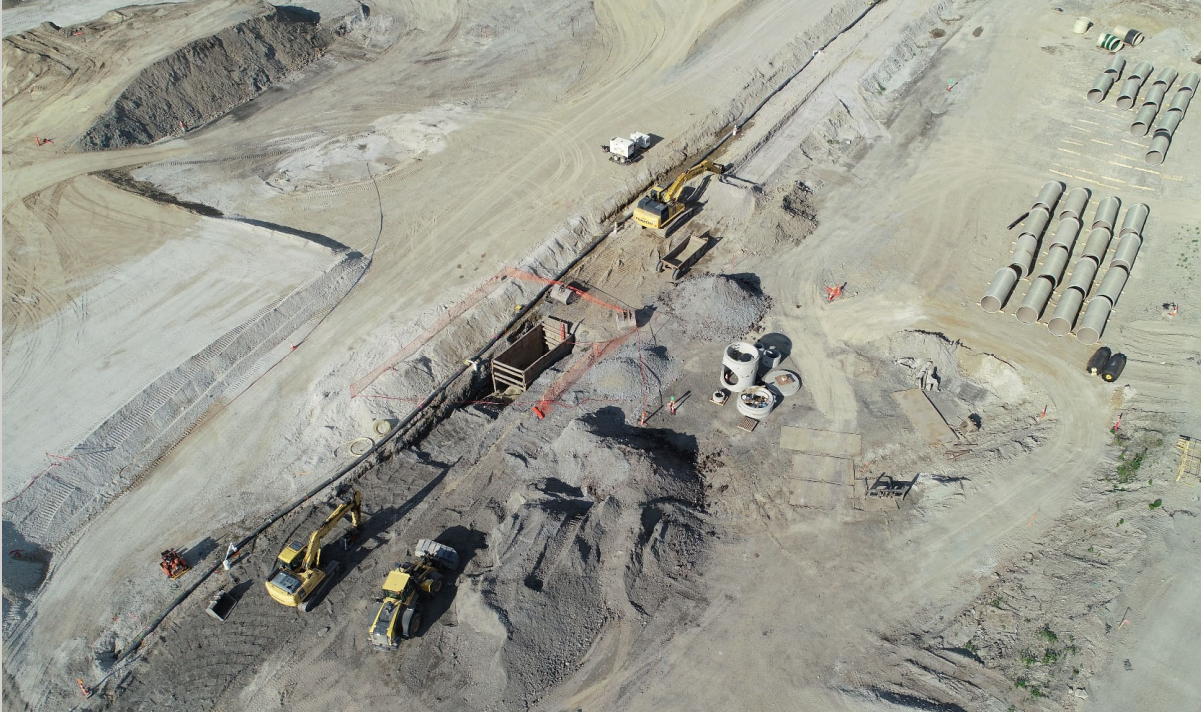
Stormwater Detention Vaults

- 3 vaults
- 200 – 800 precast panels each
- 12,500 – 52,000 SF footprints
- 620,000 – 3,150,000 gal capacity
- 47,000 CY excavated
 - 25,000 CY from North Vault

- **Stormwater Detention Vaults**
 - 21 panels/day
 - Construction of all 3 completed
 - Backfilling final, largest vault

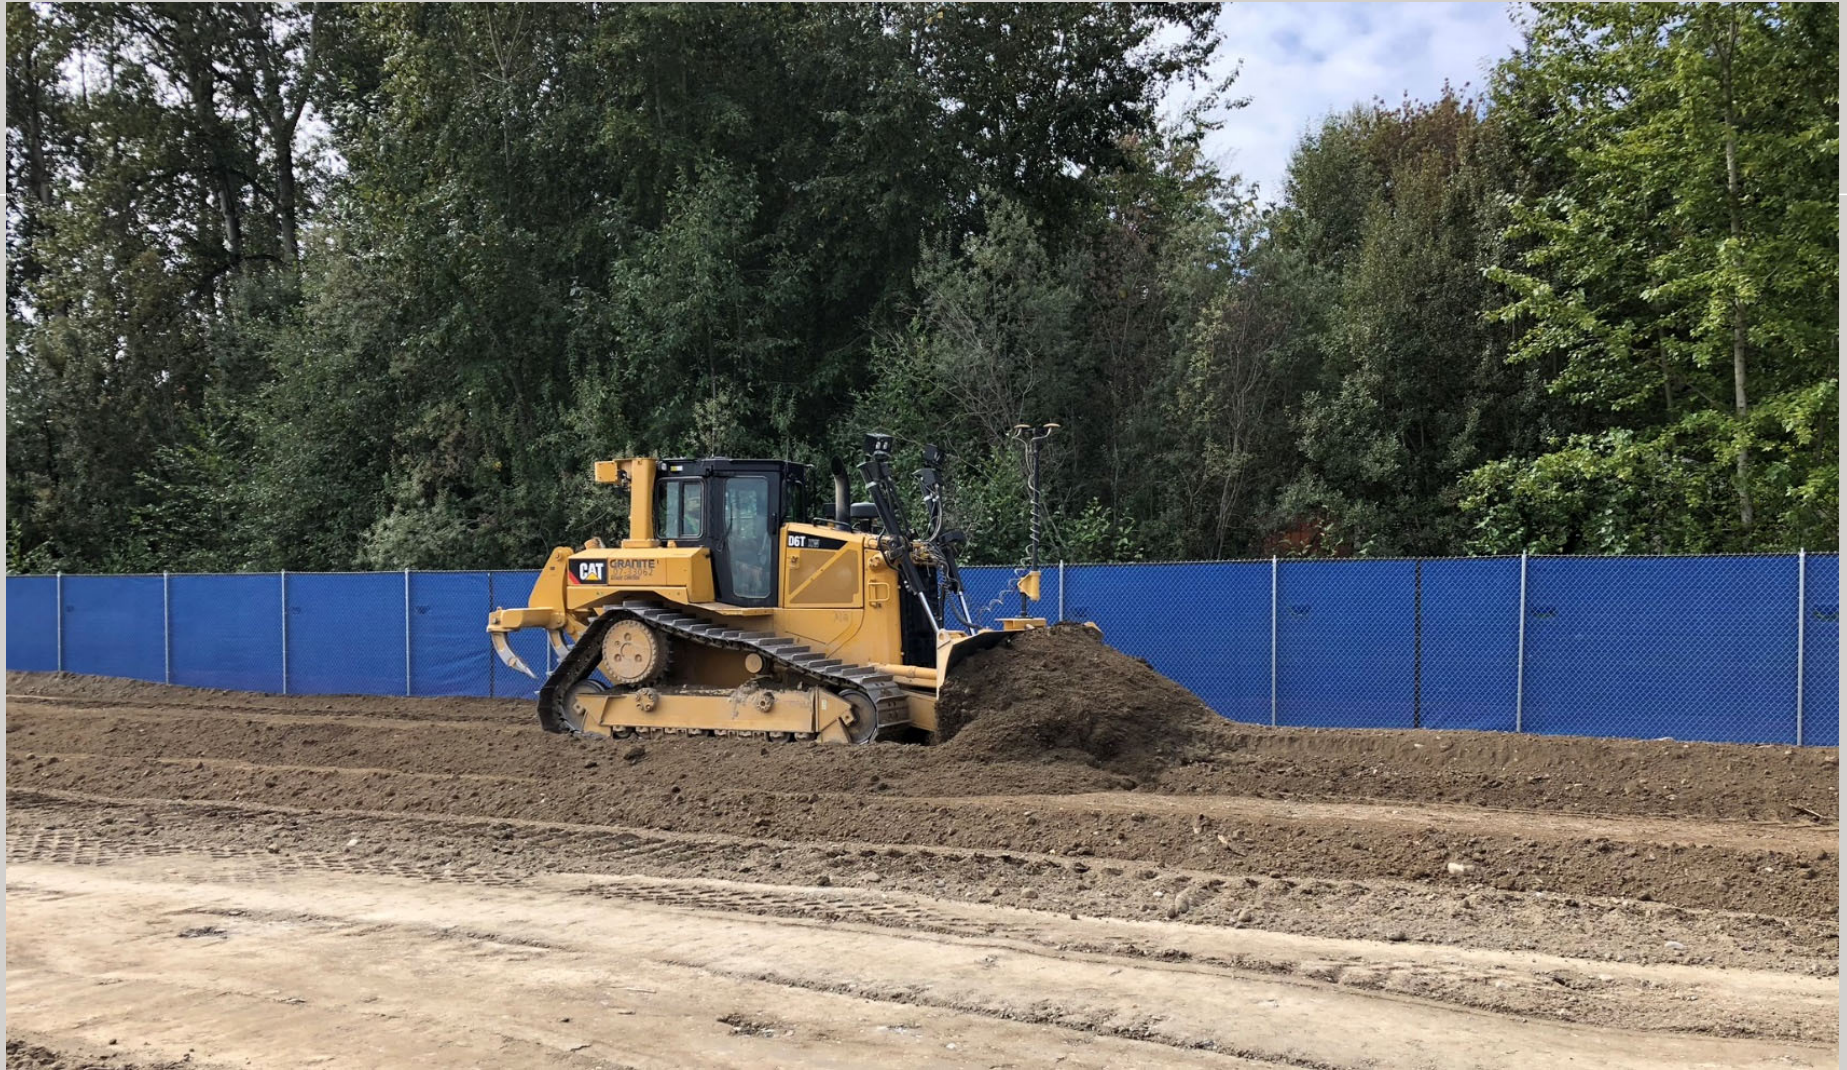
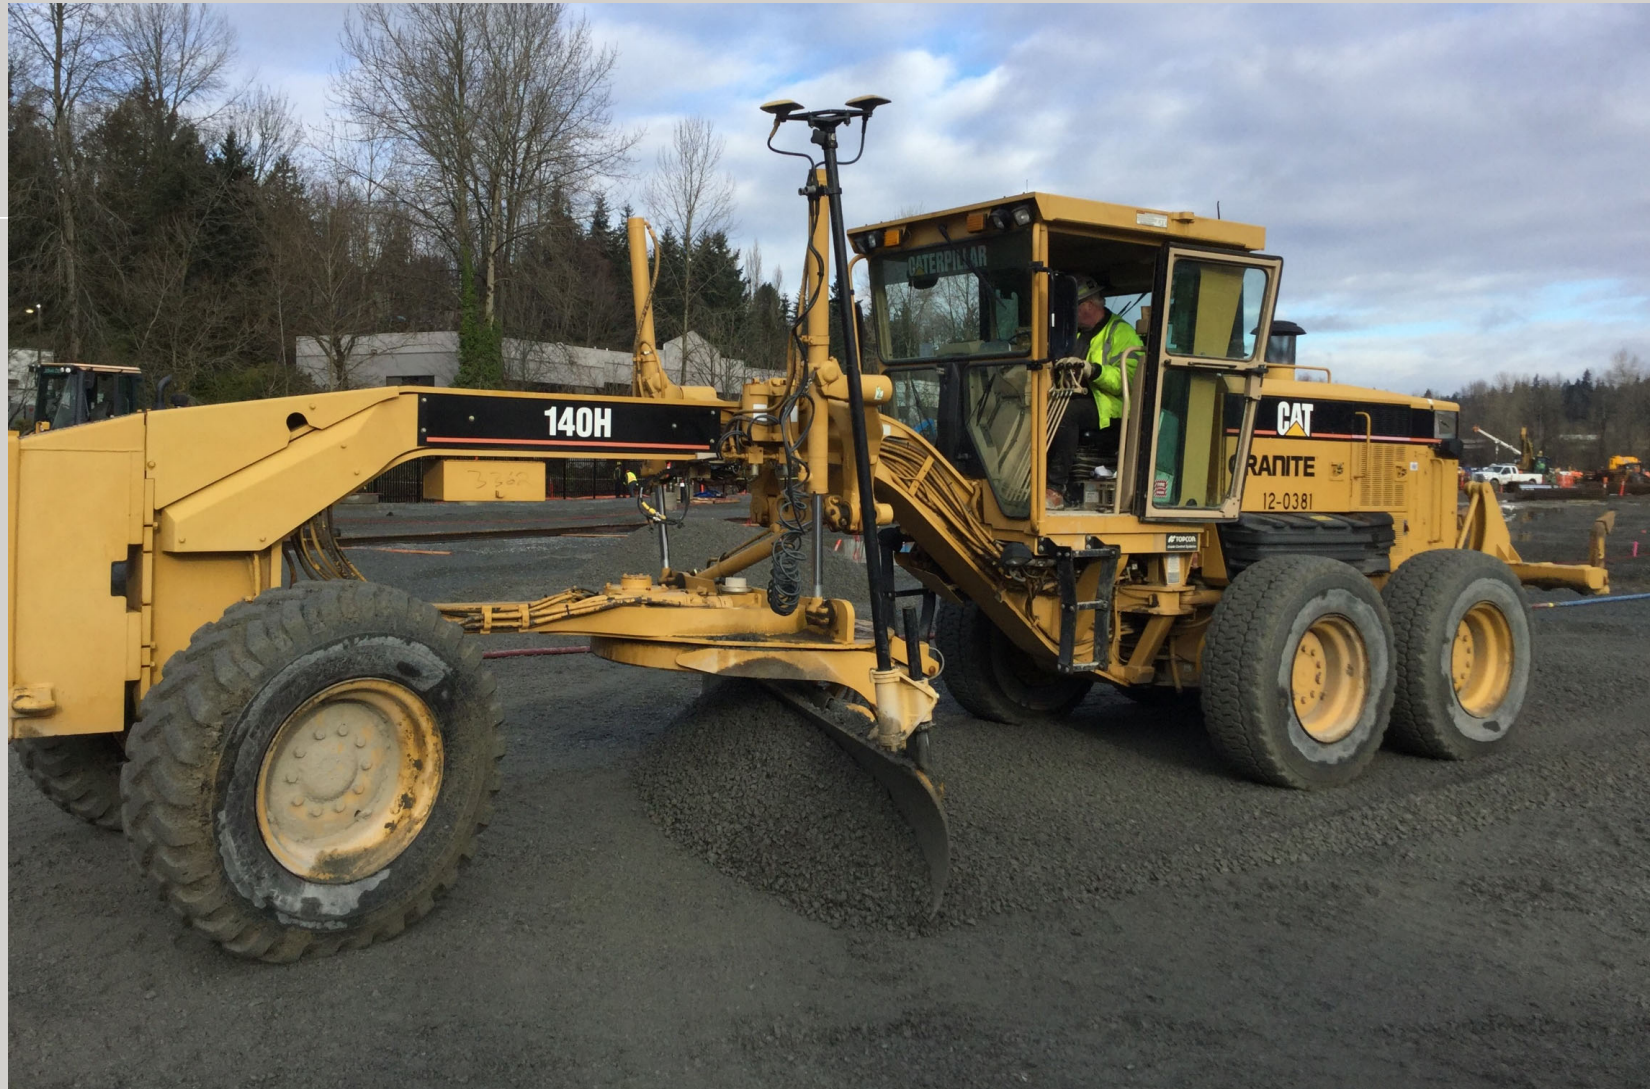
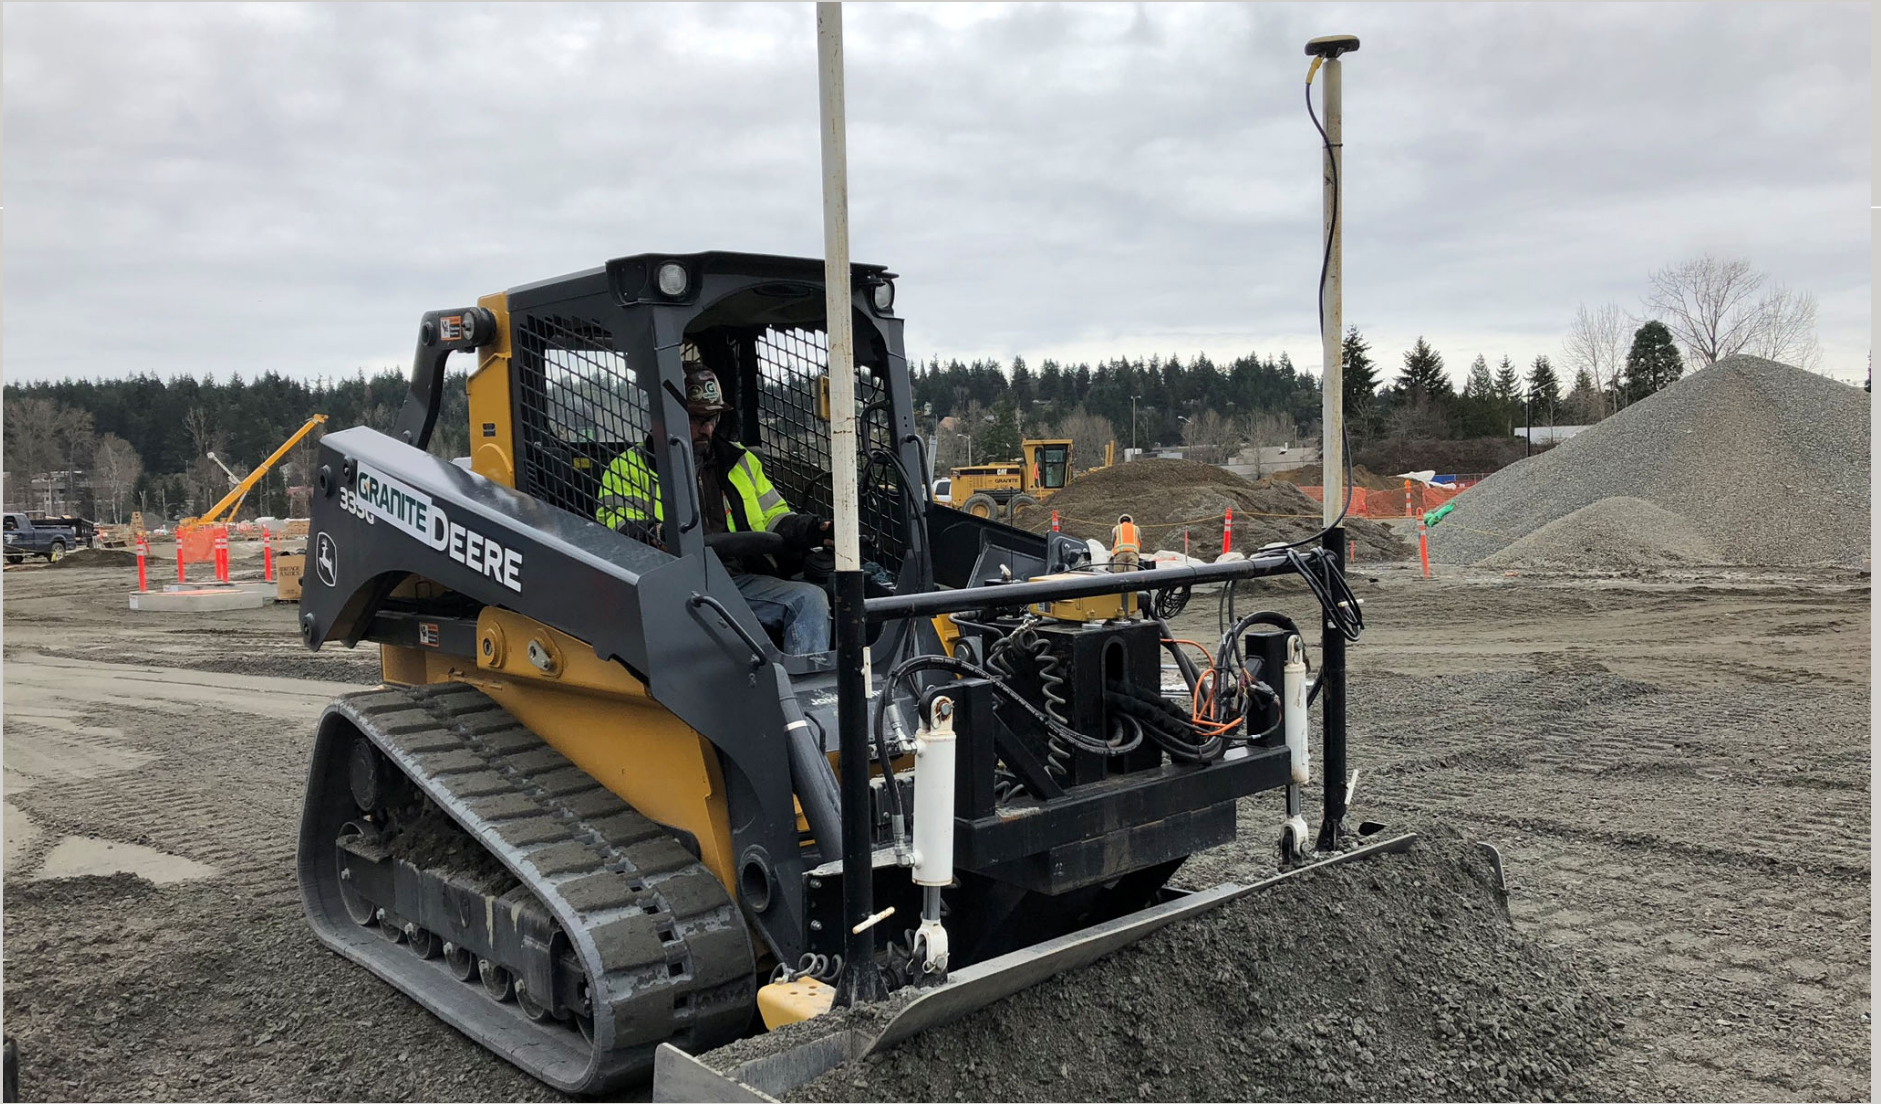
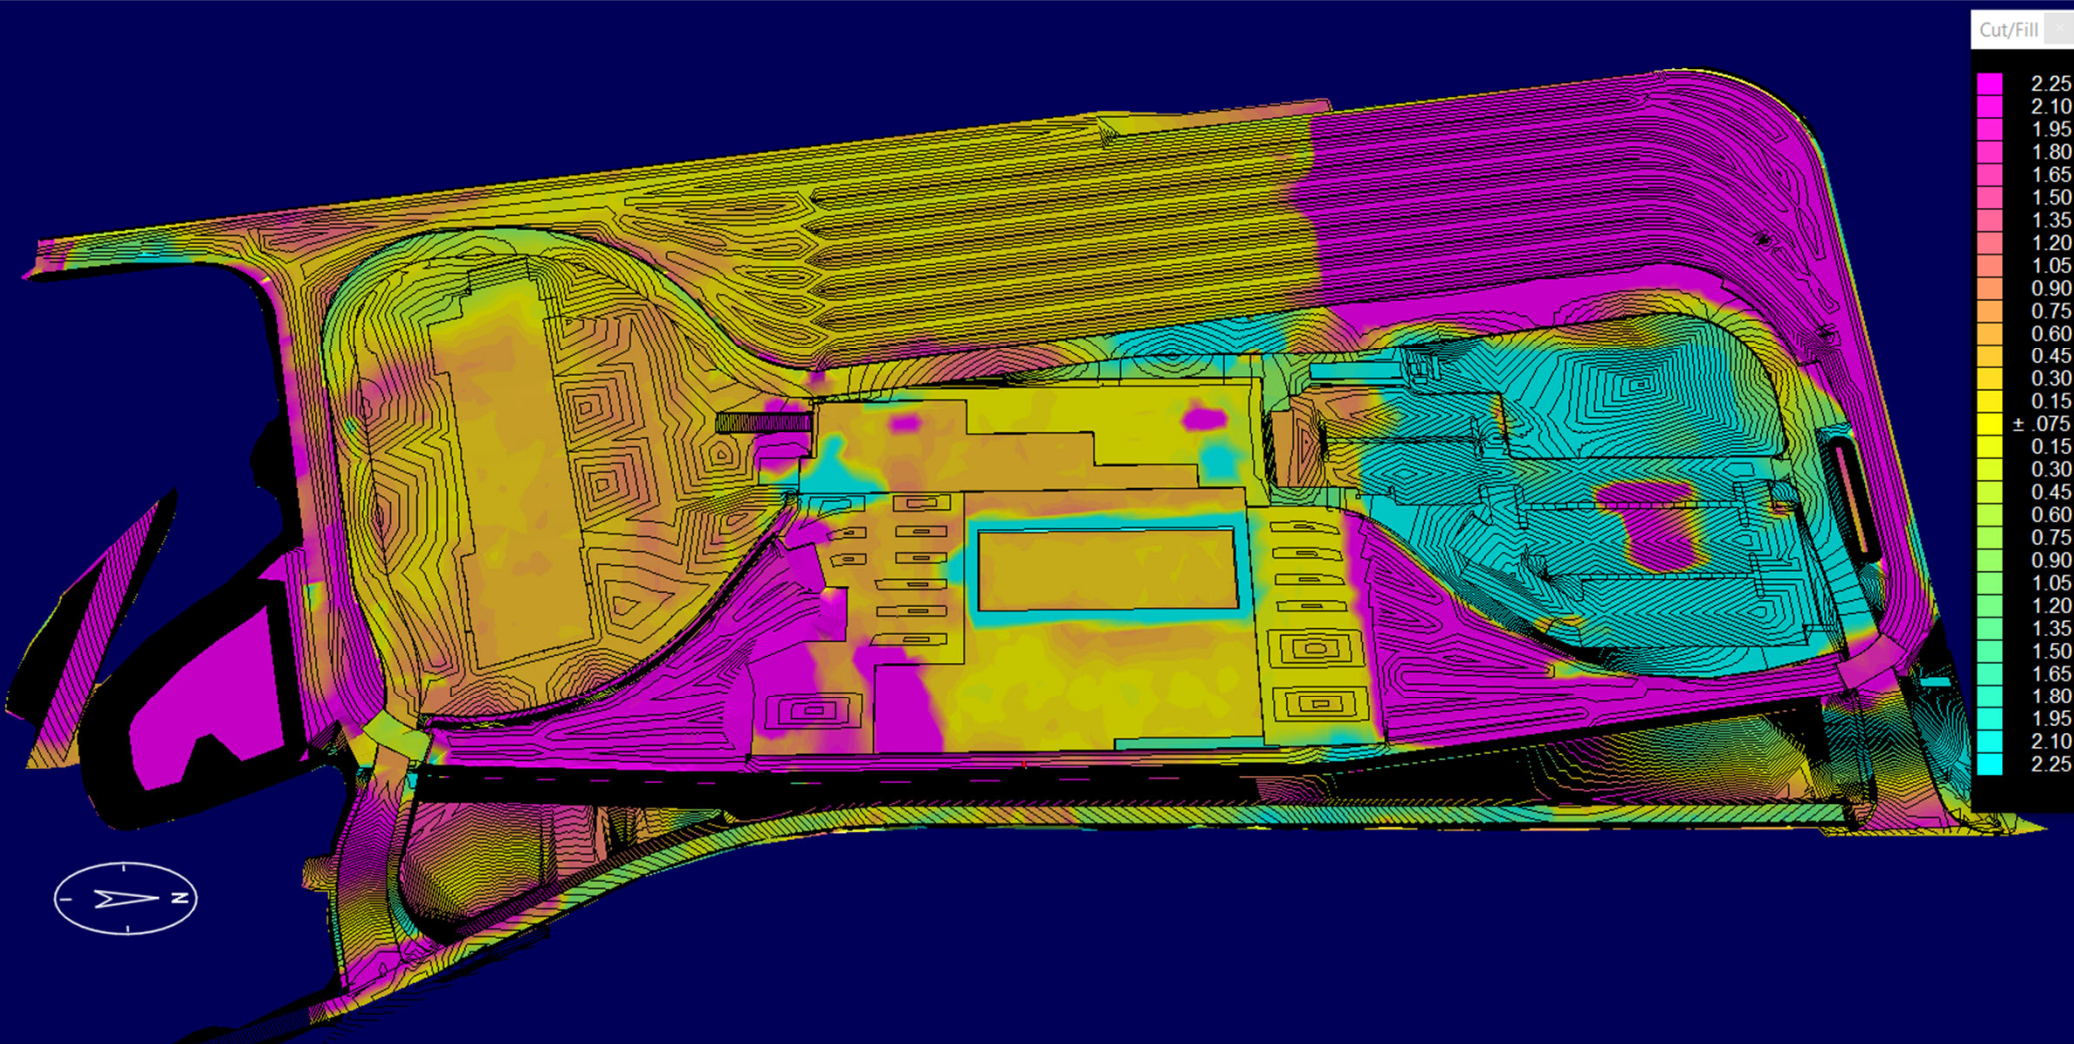
- **GPS and mmGPS**
 - Machine Control and Rovers
 - D6 Dozer
 - Cat 140H Grader
 - JD Skidsteer
 - Two rovers/data collectors
 - Accuracy
 - +/- 0.05' horizontal and vertical with RTK
 - +/- 0.01' vertical with mmGPS

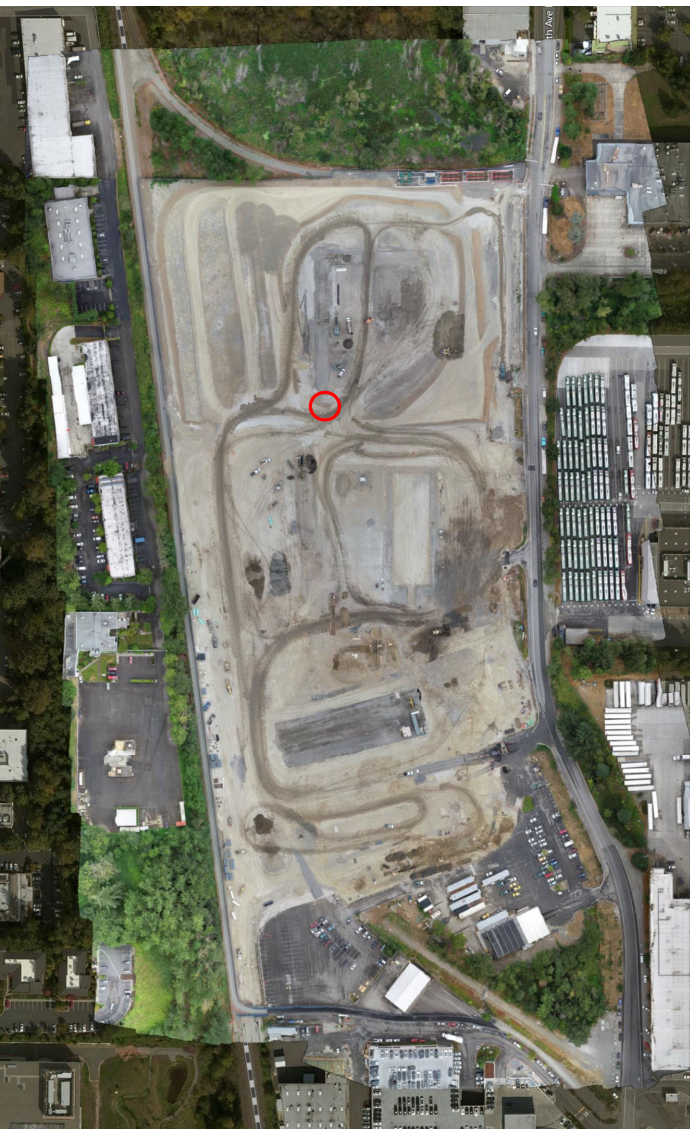
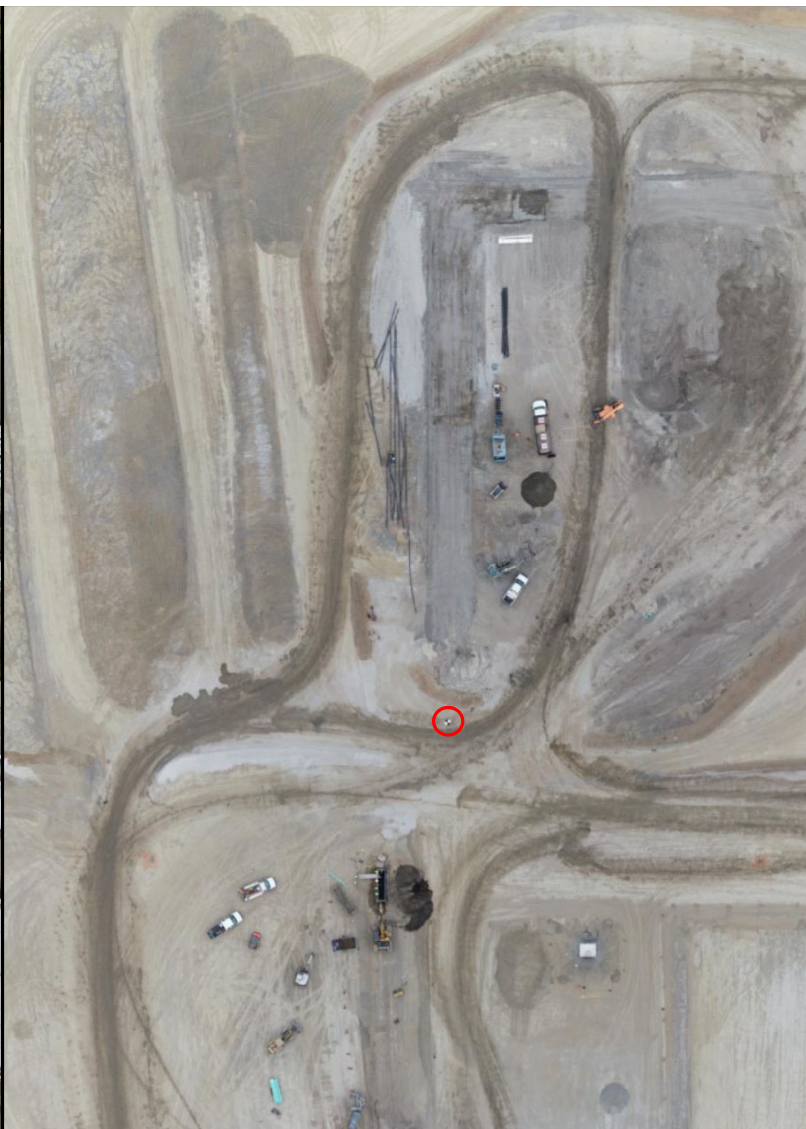
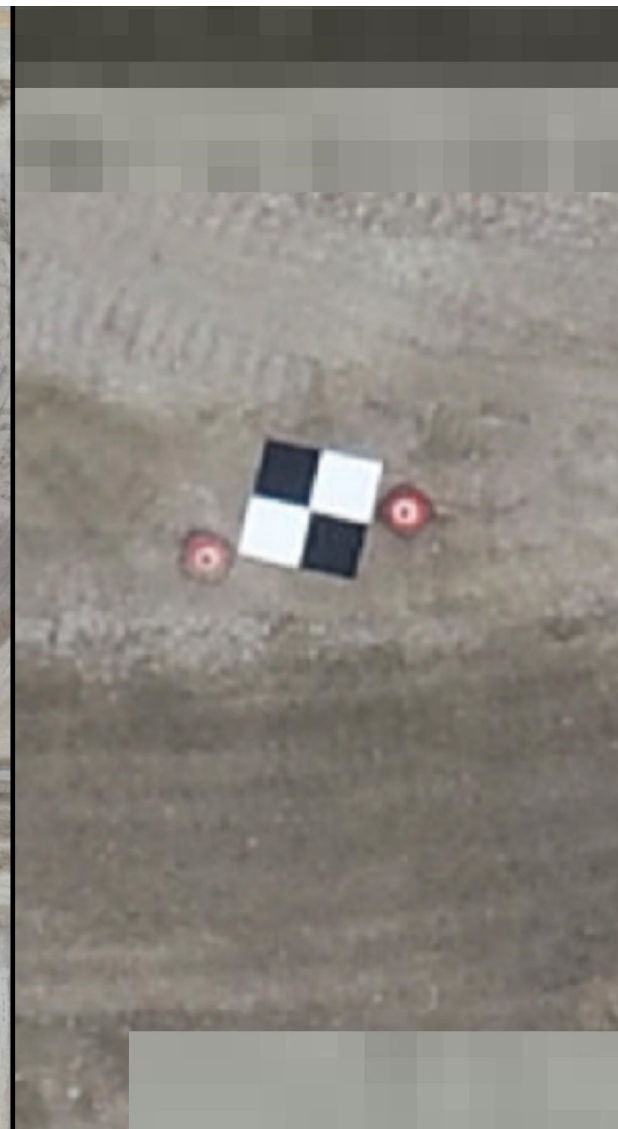
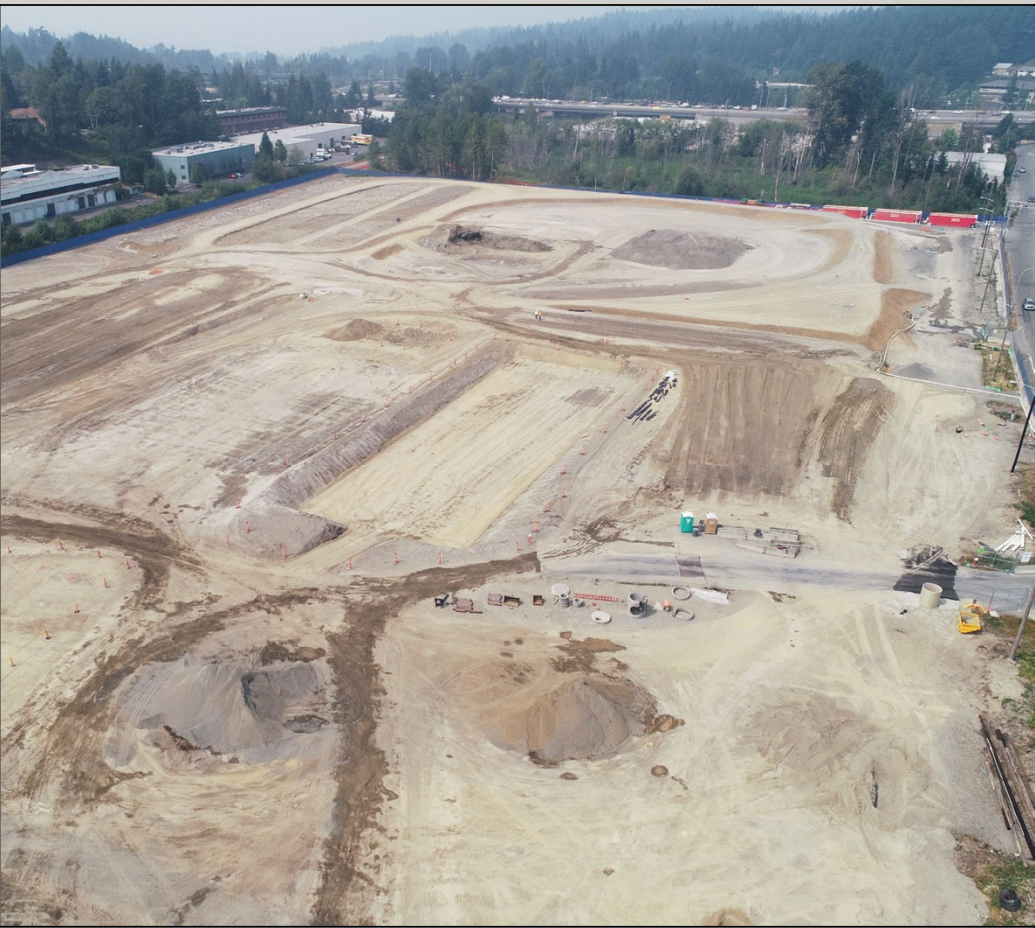
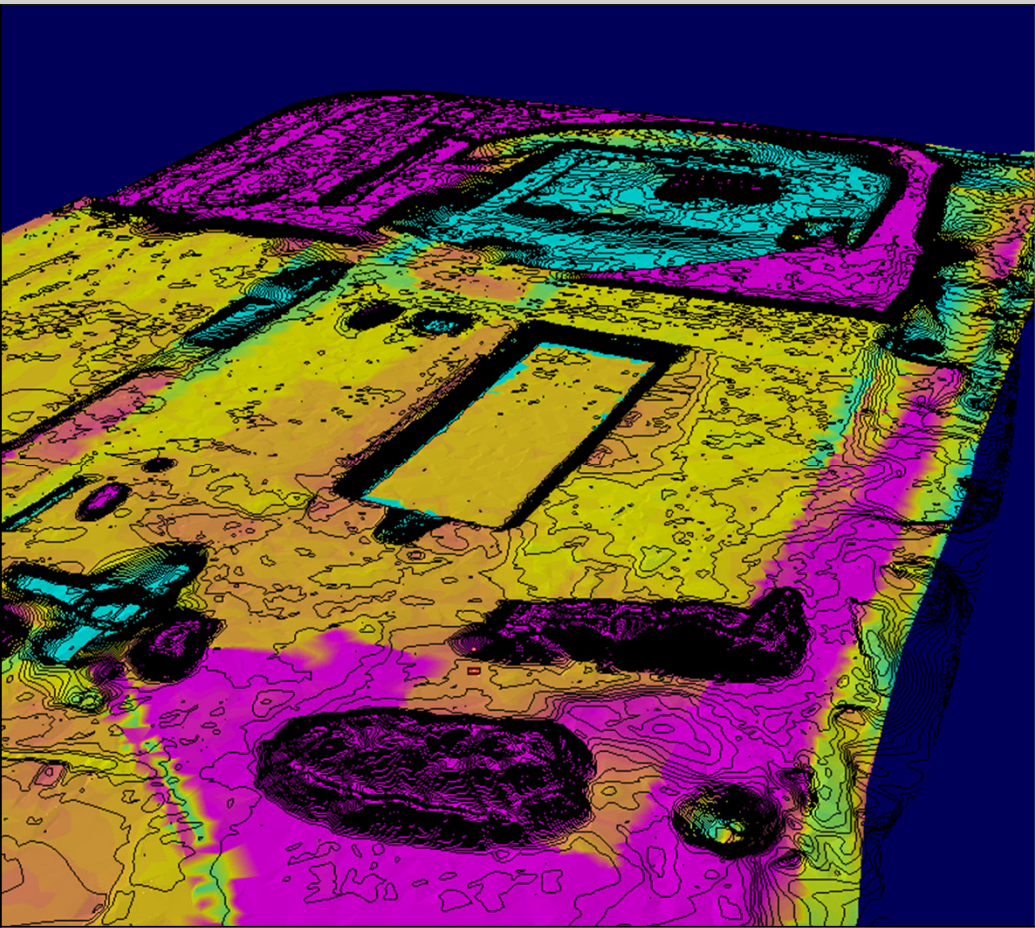
- **Drones**
 - Progress photos
 - 30 min flight
 - 3rd party processing
 - 24 hr turn around for high resolution imagery
 - Quantities
 - Quick local measurements
 - Overall cut fill balances with control points/GPS
 - Survey cost savings

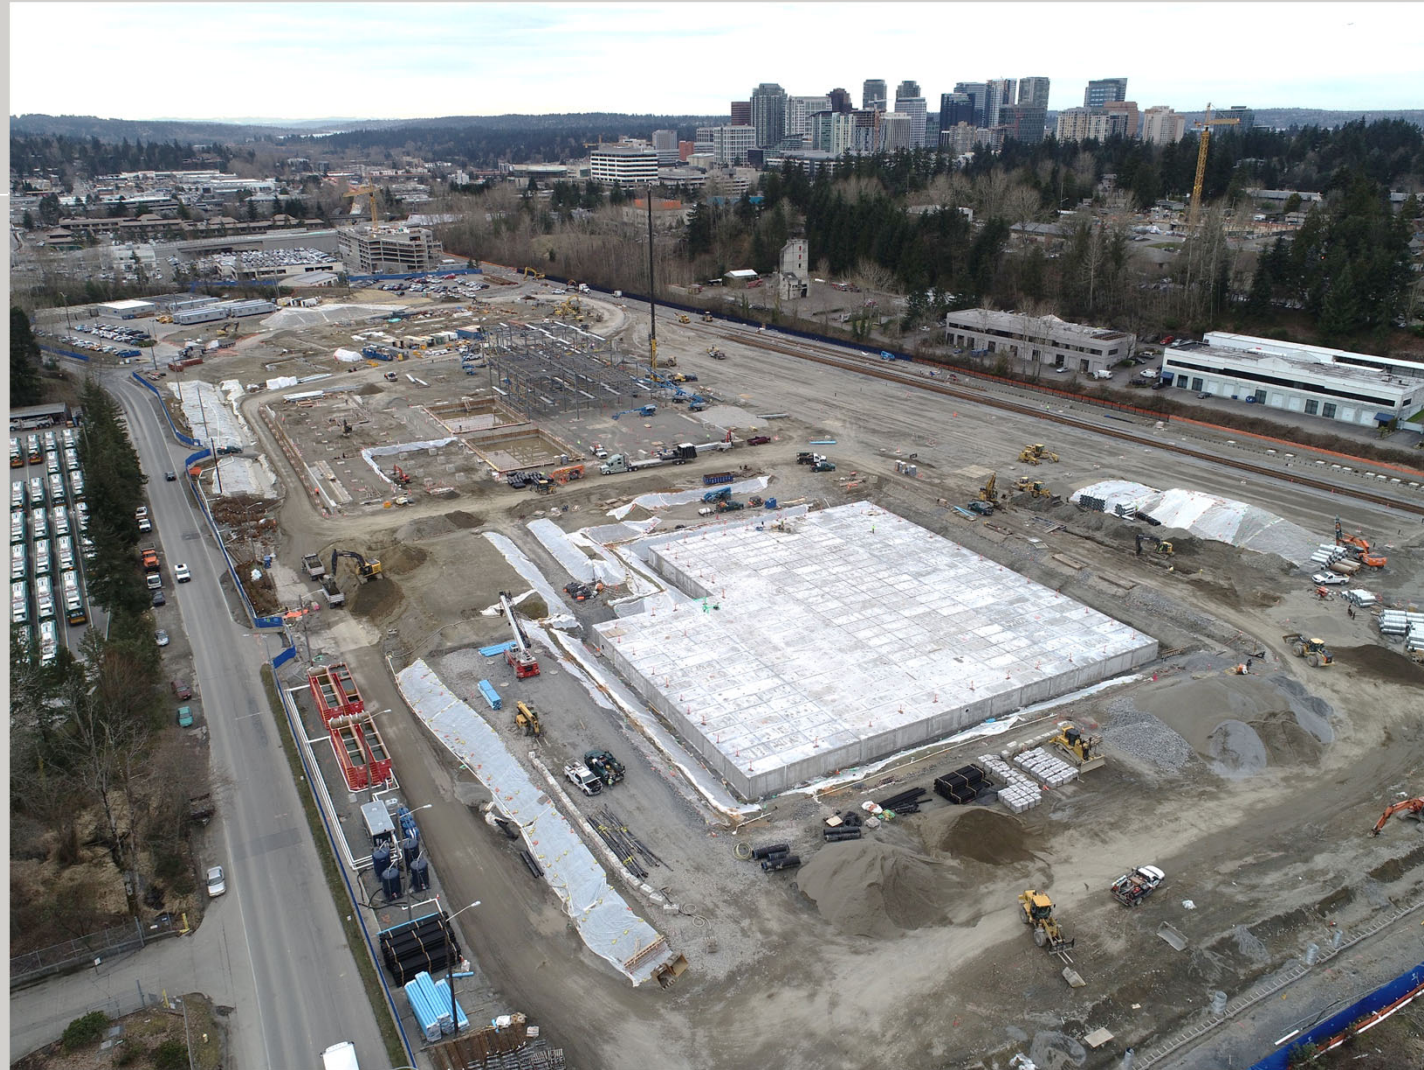
- **Soil infiltration issues requiring redesign**
 - Larger detention vaults required
 - Overall storm drainage redesign

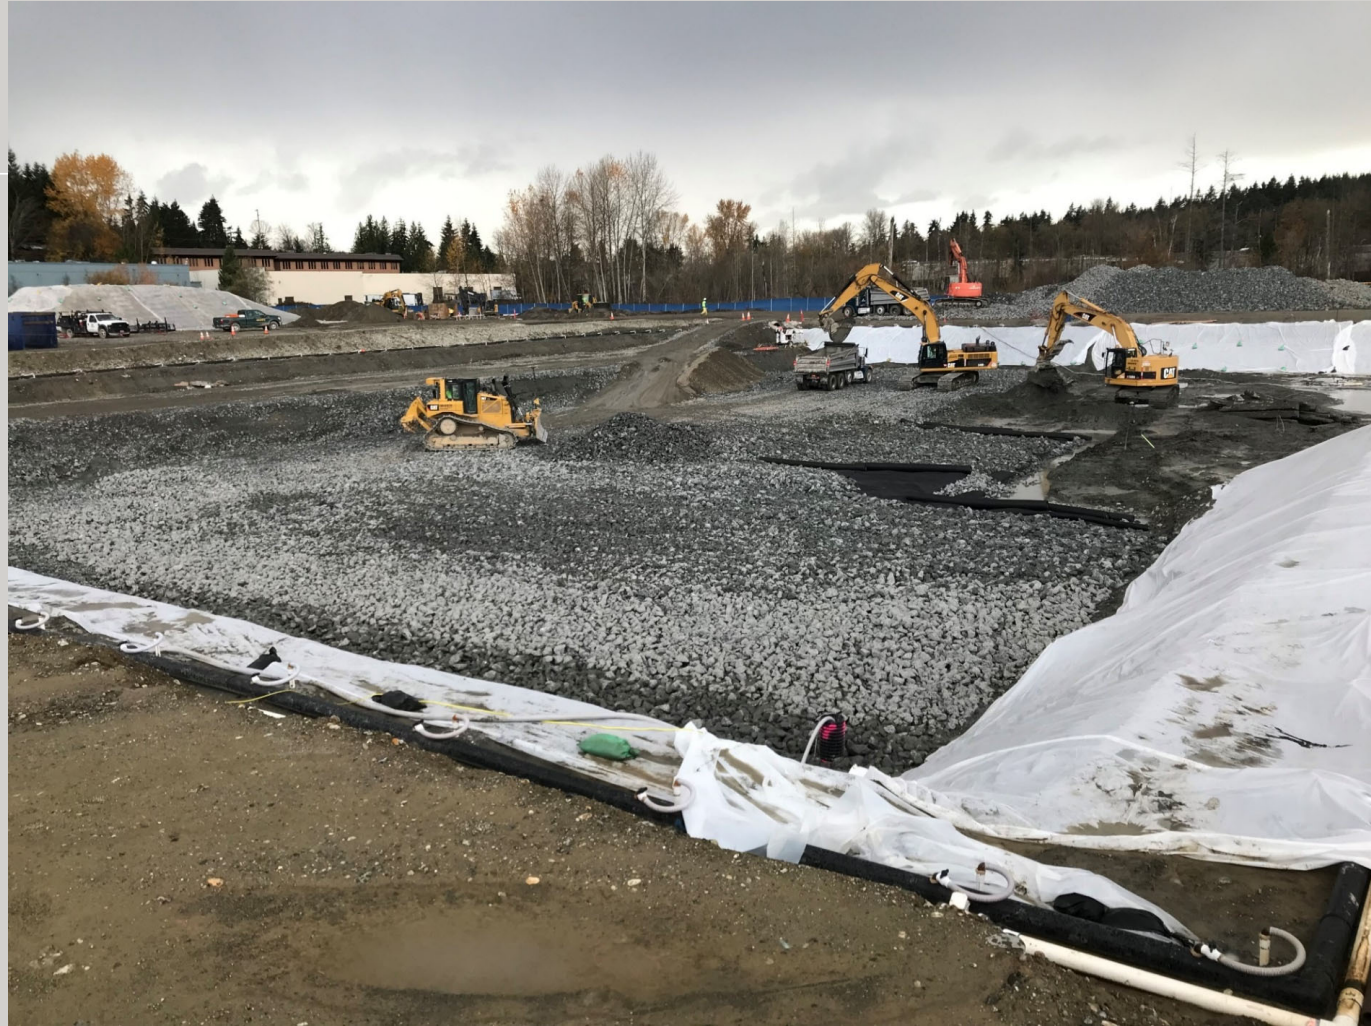
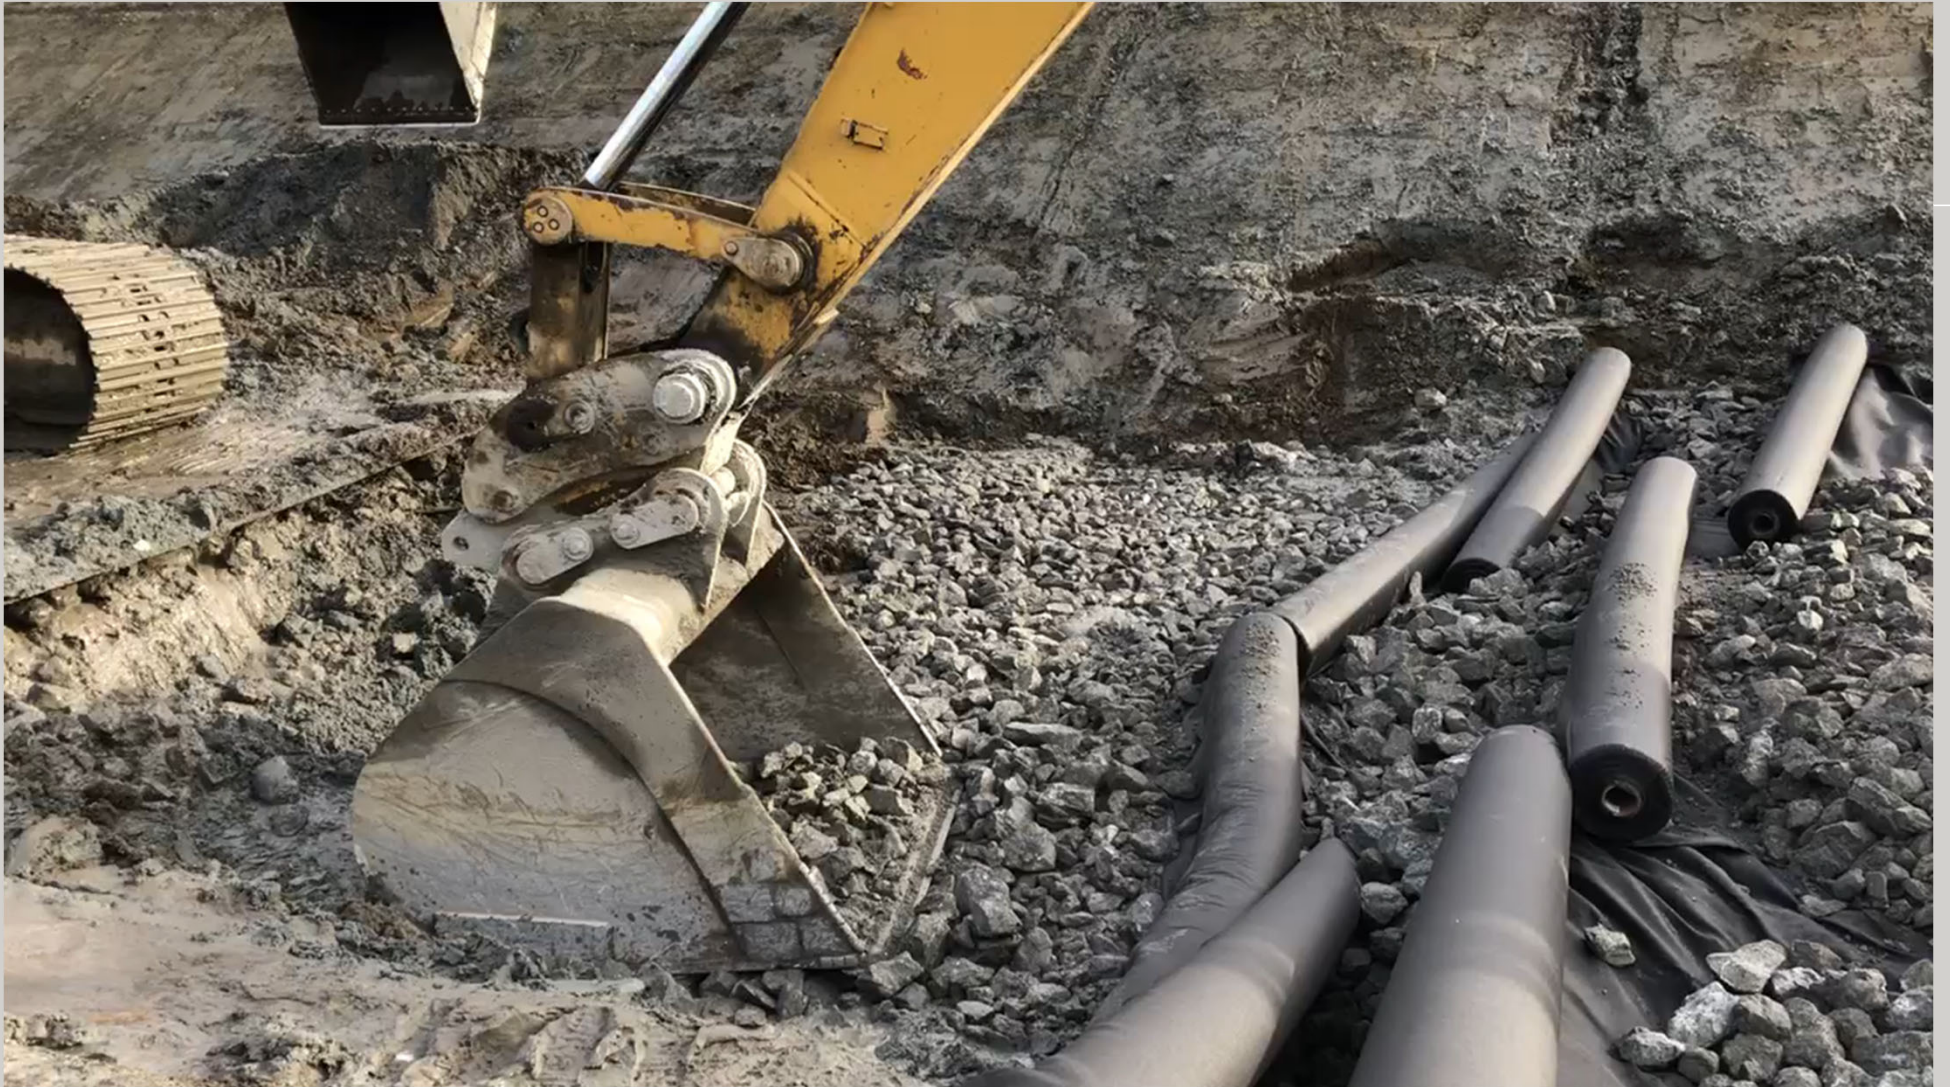
- **Poor soil conditions on north end**
 - 3' over-excavation required under largest vault
 - 13,000 TN of spalls
 - 6,500 CY of unsuitable material

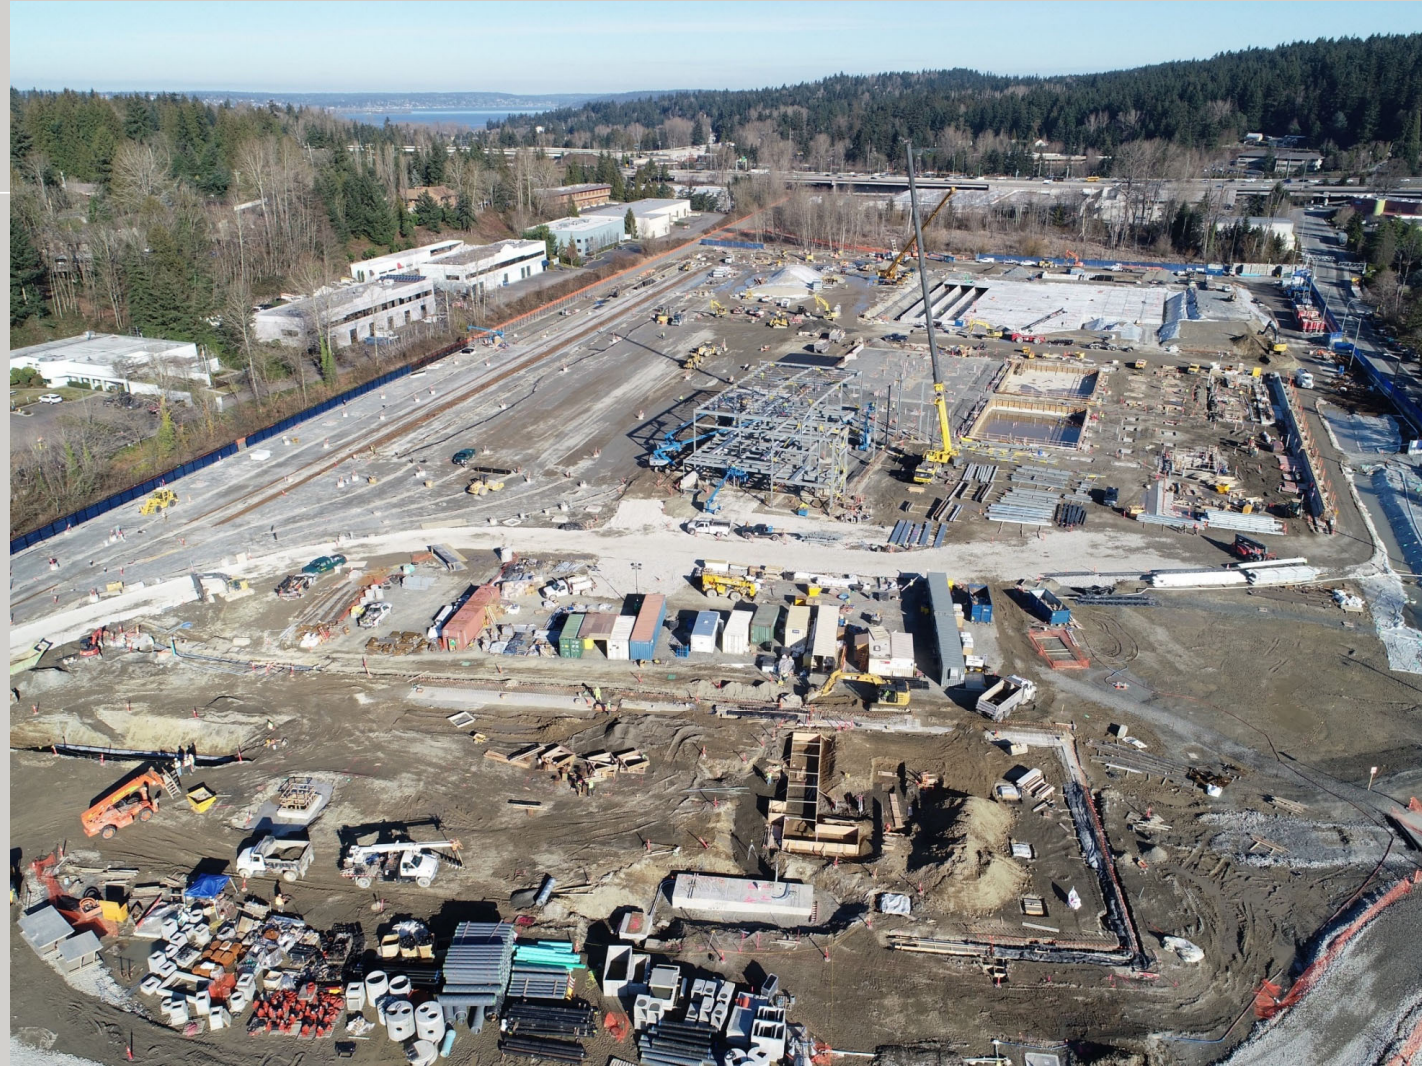
Challenges

- Congested work areas
- Design/Build coordination
