Overview of Vulnerable Buildings & Seismic Ordinances

Erica C. Fischer, PhD, PE

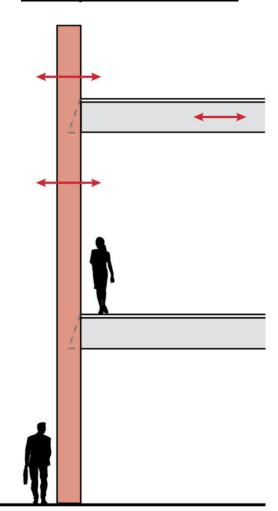
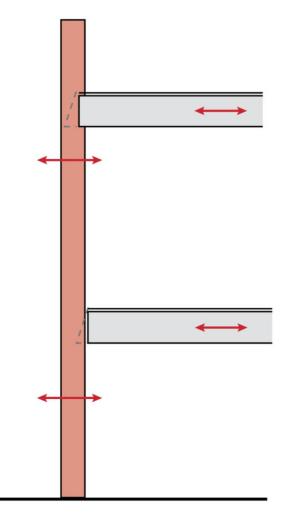
Unreinforced Masonry Buildings

Parapet breaks off

Building collapse

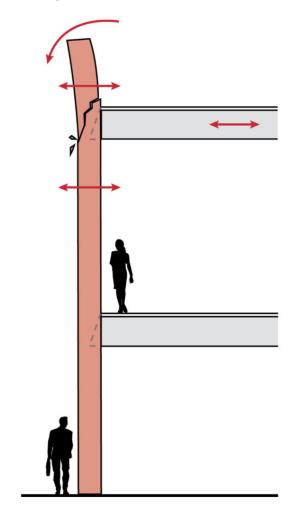
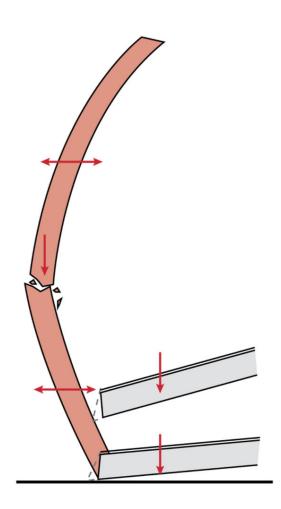
Unreinforced Masonry Buildings

Parapet breaks off

Building collapse

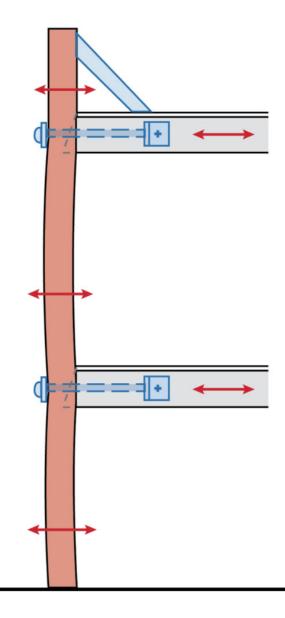
Vulnerable Building Construction *Unreinforced Masonry Buildings*

- Provide mechanical connection between floors and walls
- Strengthen parapet and connect it back to the roof

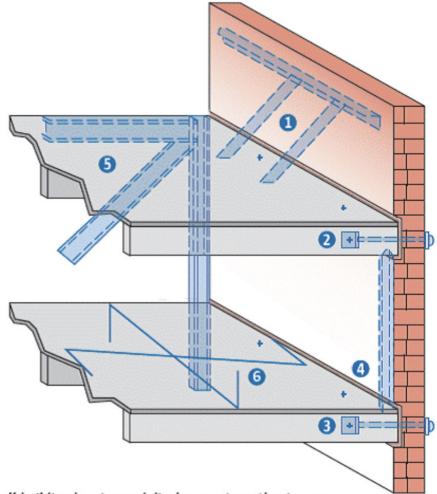
Unreinforced Masonry Buildings

REQUIRED

- Parapet bracing: The portions of a wall that extend past the roof (parapet) need a diagonal bracing that is generally made of steel.
- Wall-to-roof diaphragm anchors: Steel bolts horizontally secure the brick wall to the roof. Rosettes seen on the outside of a building can indicate that this retrofit has been done.
- Wall-to-floor diaphragm anchors: Steel bolts tie the brick wall to the floors.

SOMETIMES REQUIRED

- Out-of-plane wall bracing: Steel beams that vertically connect the brick wall to the floors to keep the wall from bending.
- Overall building bracing*: Steel beams that increase a building's overall strength.
- Diaphragm strengthening*: Plywood sheathing that strengthens floors and roofs.

Note*: Overall building bracing and diaphragm strengthening are often important for buildings with large windowed shops on the first level.

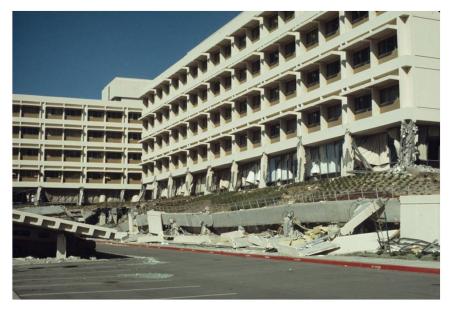
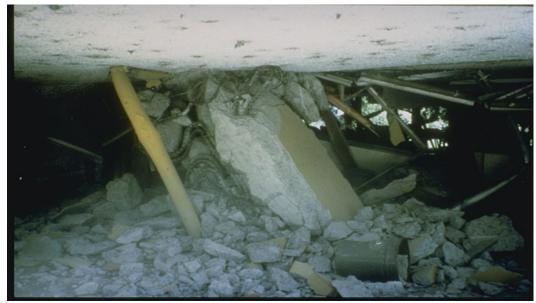
Nonductile Concrete Buildings

Mexico City earthquake (1985)
Northridge earthquake (1994)
Christ Church earthquake (2011)
Mexico City earthquake (2017)

Typical damage:

Soft story failure Severe column damage/failure

Nonductile Concrete Buildings

- Structures that contain brittle concrete elements (columns, beams, walls, and connections)
- Perform poorly during earthquakes due to the limited amount of provided reinforcing steel
- Usually built prior to 1980
