Gecko Robotics: Advanced UT Inspections

"Applying New Technologies to Your Project"

Gecko Robotics: Tank Shell Inspection via Rapid Ultrasonic Gridding

Hydrogen Damage Case Study: Butane Sphere

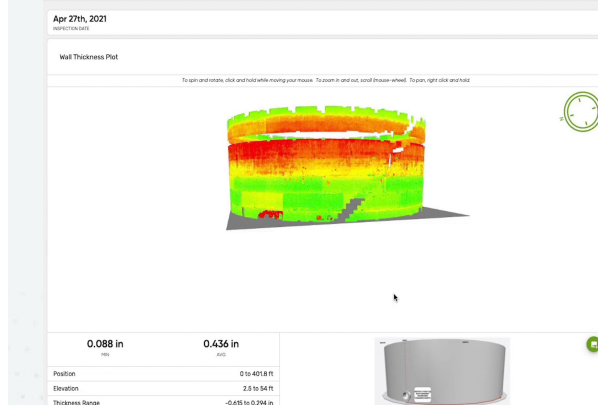
- Tank 203: 56' tall / 128' diameter.
- Tank 204: 53' tall / 96' diameter.
- Scope of work was 100% external UT scan on both tanks to determine internal coating condition and corrosion identification.

- Opportunity
 - Reduced Tk203 repair scope from full replacement (\$1.2M) to replacing 1 course w/minor patching (\$270K)
 - Performing the inspection online reduced tank outage timeframe for initial discovery insp.
 - Scope completed in 3 days @ 24K
 - Traditional AUT proposal was 5.2 weeks @ \$48K
- Execution
 - No scaffolding required – ground access with JLG for repositioning above wind girder
 - Fast scanning of 30ft./min.
 - Gecko utilizes chicago style hose fittings
- Data
 - 39M readings between both tanks obtained
 - Follow up UT performed to confirm lamination calls & validate data
 - Gecko Portal allows ease of viewing 3D rendering with thickness overlaid using color schemes

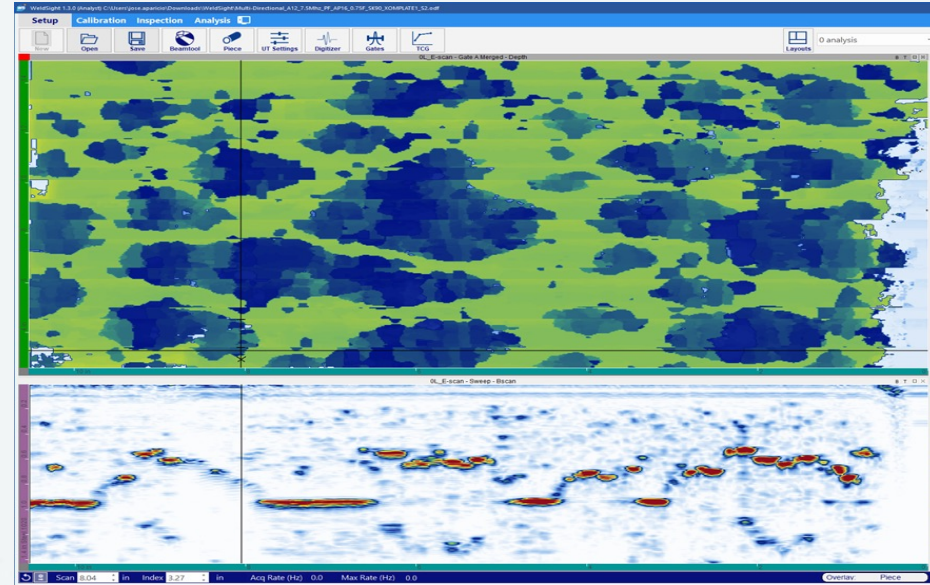
Tri-Lateral Phased Array

A, B, C, and D scans to visualize the depth and severity level of subsurface damage.

Positively identify laminations, inclusions, blisters, periphery cracking, and stepwise cracking.

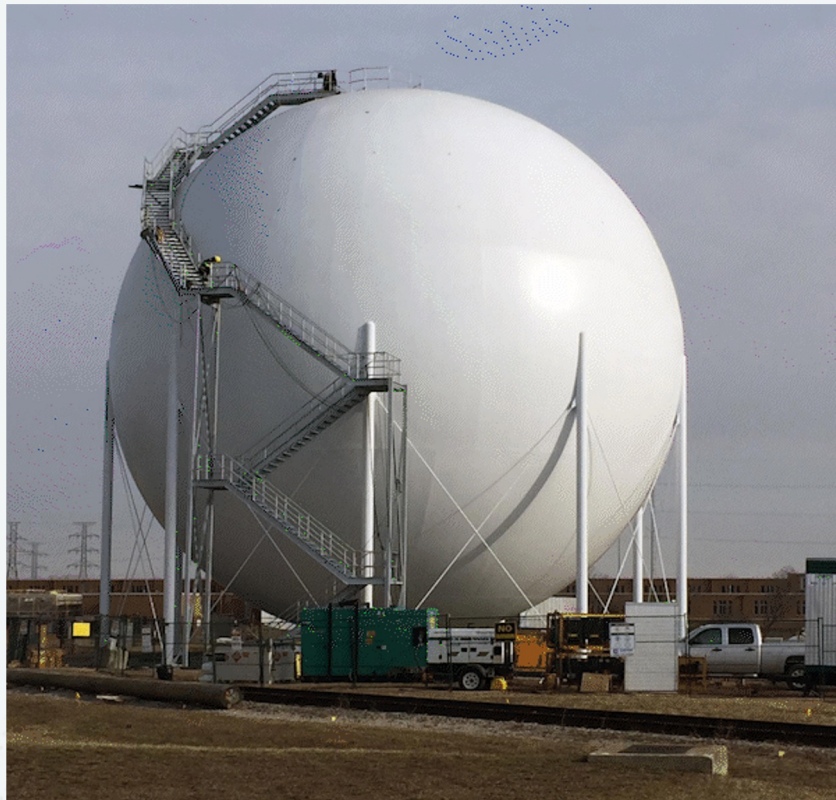
- Option A) External Tri-Lateral Shell + External Automated PAUT Weld inspection
- 12 shifts, ~\$120,000k (60% cost savings, 60% time savings)
- No scaffolding or vessel entry required for inspection

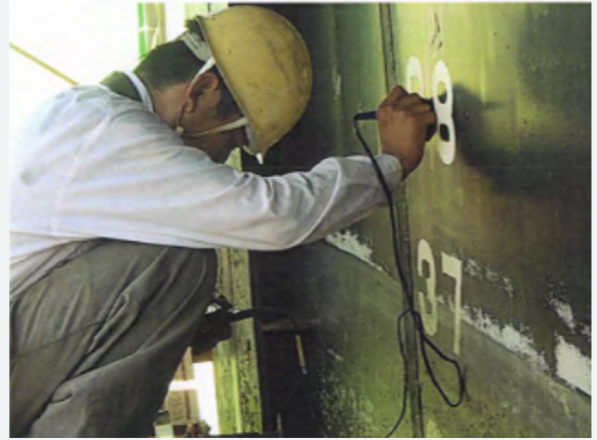
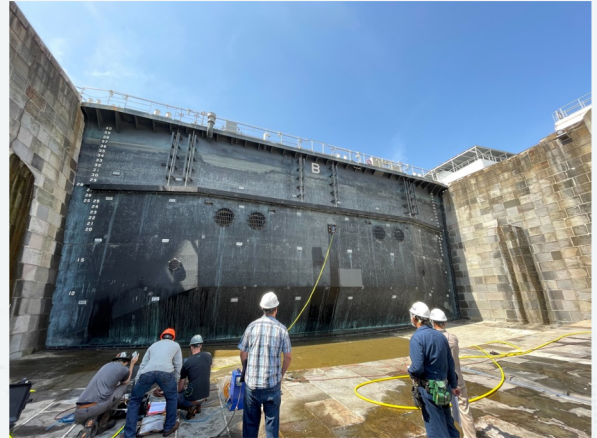
Caisson Scan Data

- 10 man hours (25x reduction), 13 hour cycle time (8x reduction)
- Full comprehensive digital data set for assessment and remediation
- Corrosion map displays millions of UT readings with images
- Online portal provides rapid insight and fuel AI/ML models for condition based maintenance transition

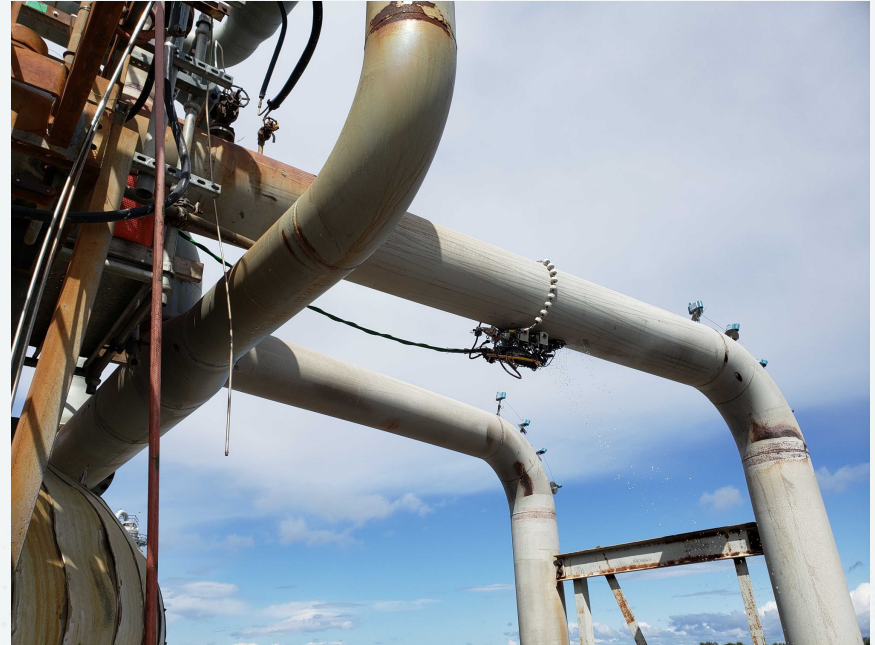
Piping Case Study (Overhead Crude Line)

- Scan piping with TOKA Flex platform
- 400 A-scans per square foot of surface
- No scaffolding or ropes
- 2 shifts per inspection
- Continuous monitoring every 3 months

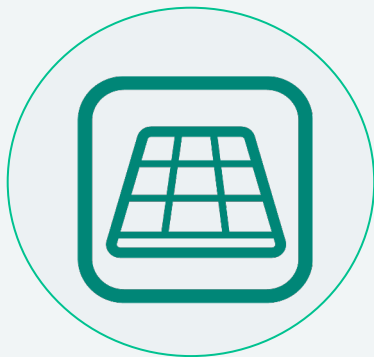
Rapid Ultrasonic Gridding (RUG)

General corrosion
5,000 ft² / 12-hour shift
Wall thickness < 0.70"
Surface temp up to 275°F

- Identifies and quantifies **corrosion, erosion, and pitting**
- Up to 24 ultrasonic testing (UT) transducers
 - **700 readings/second**
 - Ultrasonic frequency 5-10MHz
- High speed corrosion mapping
 - **Travels 3-6 inches/second**
 - 2D and 3D C-scan corrosion maps
- Onboard camera and stored HD imagery for visual inspection
 - **Scanning outside line of sight**
- Climable and steerable, limited access requirements

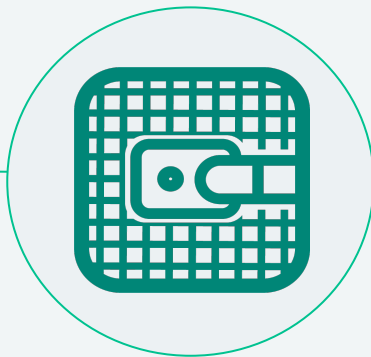
Rapid AUT (R-AUT)

Localized corrosion + pitting
500 ft² / 12-hour shift
Wall thickness 0.125-8.00"
Surface temp up to 400°F

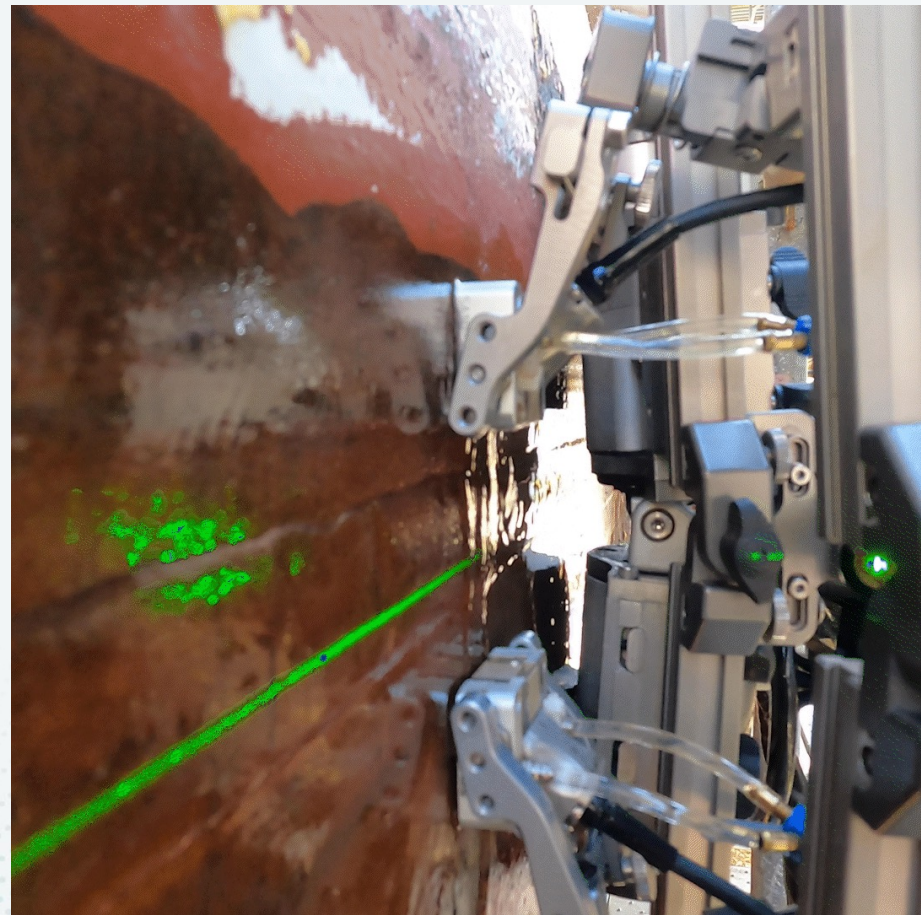
Cracking Detection and Sizing

Time of Flight Diffraction (TOFD) and **Phased Array (PAUT)** are two common tools that can be remotely deployed for the detection of discontinuities.

Remotely scan for discontinuities such as **cracks, corrosion, and flaws** with a high level of production and detection.
